Root Cause Analysis of Cracked PC Syringes

A client requested a root cause analysis of cracks and haziness that appeared in polycarbonate (PC) syringes during accelerated aging as part of a shelf-storage study. The results of the study were unexpected and revealed a few issues with the manufacturing line.

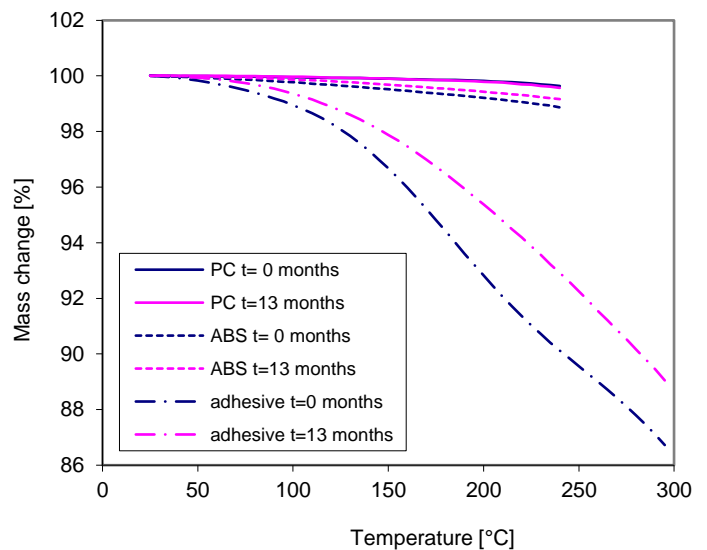
TGA of unaged and aged components of syringe.

Thermogravimetric analysis (TGA) showed that uncured epoxy adhesive may be off-gassing, but that the ABS plunger and polycarbonate barrel were not off-gassing, even after 13 months of aging. A design of experiment study with 6 variables (hand oil, humidity, EtO sterilization, unreacted epoxy monomer, ABS plunger, and an isopropyl alcohol wipe) was conducted with accelerated aging to see which conditions led to cracking and haziness. No single parameter led to cracking or haziness, but rather a combination of hand oil or monomer coupled with EtO sterilization or humidity resulted in cracking and haziness. IPA wiping reduced haziness and cracking, even with these materials present.

The client instituted retraining on wearing gloves during assembly, increased the UV cure time for the epoxy, and included an IPA wipe during cleaning to remove items that could result in the environmental stress cracking observed.
